Seismic risk assessment of reinforced concrete buildings in Koyna Warna region through EDRI method

Report No: IIIT/TR/2021/-1

Seismic risk assessment of reinforced concrete buildings in Koyna-Warna region through EDRI method

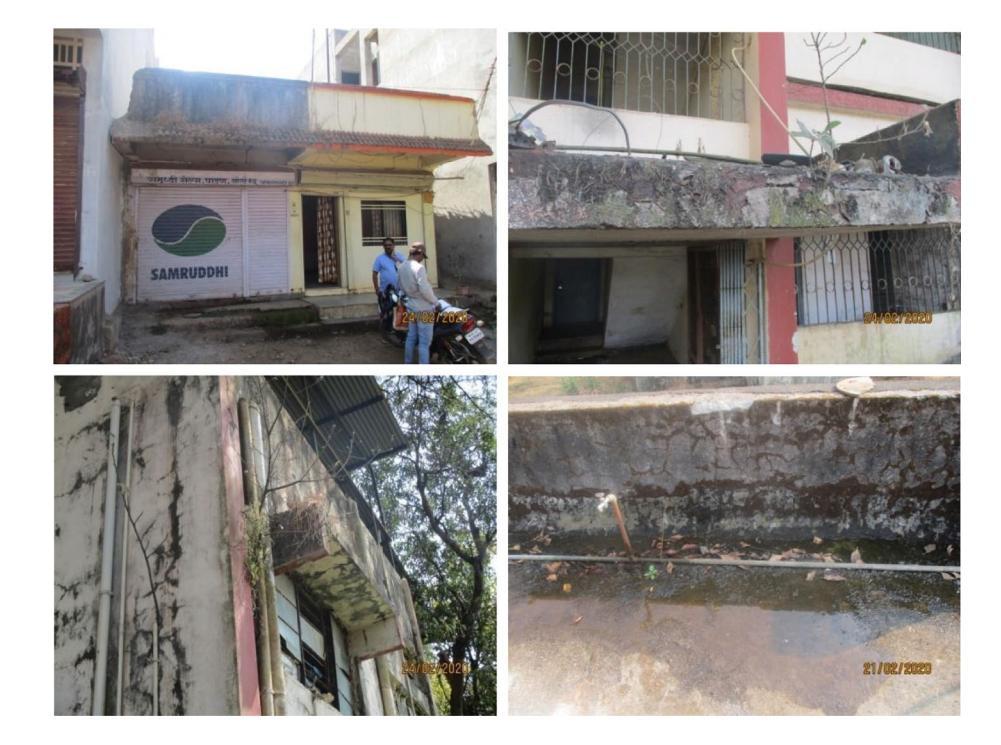
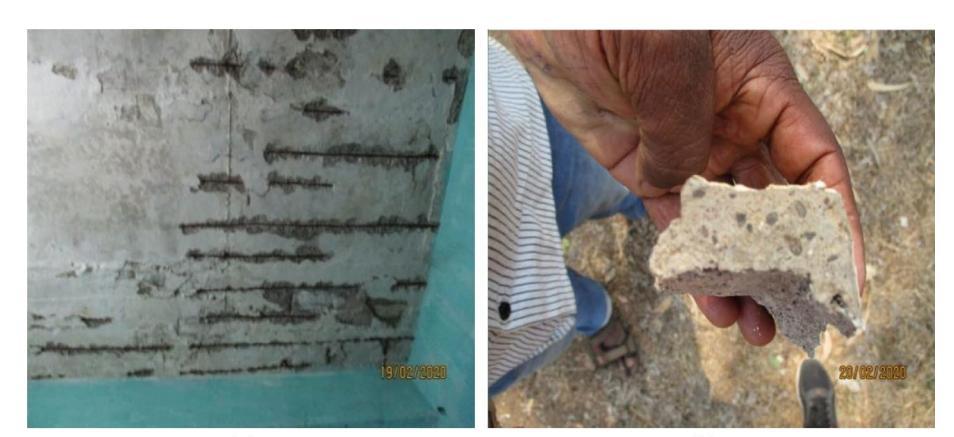
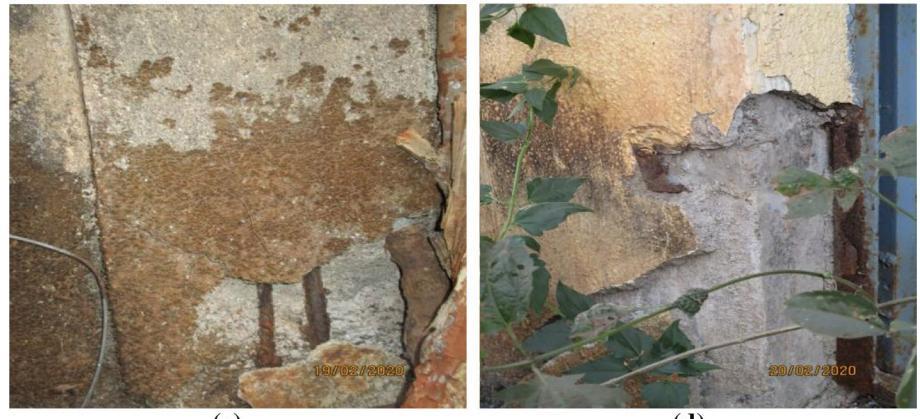
have observed the damage condition of structural members like spalling of cover concrete, corrosion of reinforcement, etc. In many of the constructions, the inadequate concrete cover is provided, so due to less concrete cover provision reinforcements are exposed and corroded. Similarly, in the case of slab we observed reinforcements are corroded and exposed out due to many of the reasons, namely material deterioration due to environmental condition, poor quality of material and workmanship, also provision of less concrete cover, etc. In this study, we have seen the concrete cover provided to the column is around 20 mm as shown in Fig. 9 (b), and as per codal provisions, it should be 40 mm. So the structural failure is like a nightmare and it haunts the construction industry.

Fig. 9 a Reinforcement are exposed in slab, b Sample of cover concrete of column, c Corrosion of reinforcement, d Spalling of cover concrete

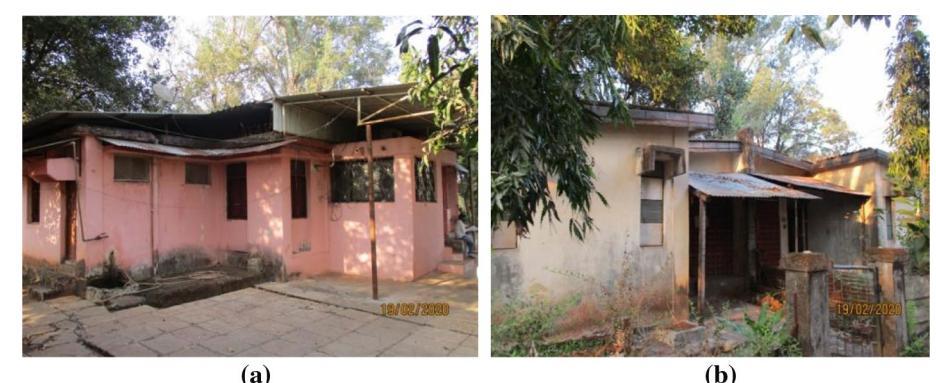
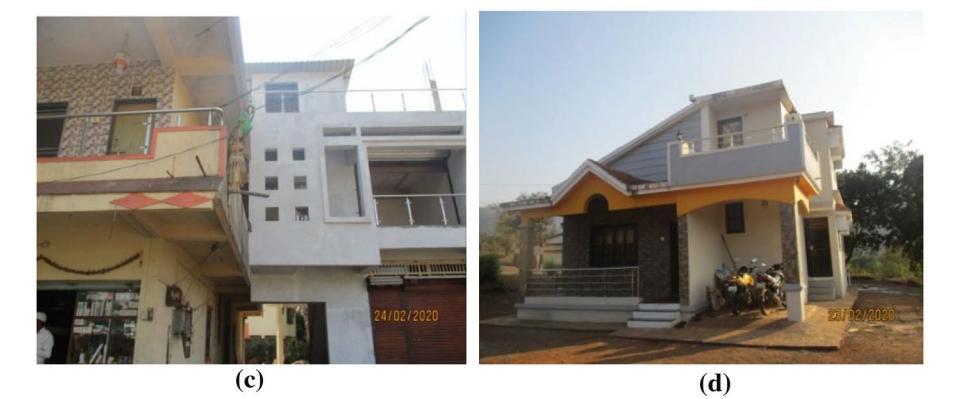
Settlement of a building is a geotechnical problem. In the field study, we have observed that one commercial building is constructed in the hilly region and behind the portion of a building was the valley region. The backside ground portion of the building is settled moderately due to loss of strength of soil. So the corner column foundation is slightly Fig. 10 a Reentrant corner present in split roof structure, **b** Pitched roof structure, **c** Two RC buildings connected with each other, d Irregular structure

damaged and the temporary constructed infill wall is damaged completely. The major crack was propagated through the ground due to the settlement problem. This building is most vulnerable in a future earthquake event. The failure of a building is shown in Fig. 12.

Fig. 12 a Building constructed on hill top b Backside portion of building c Collapsed wall due to settlement of soil, d Corner column foundation slightly damaged and loss of upper soil strata up to the foundation depth

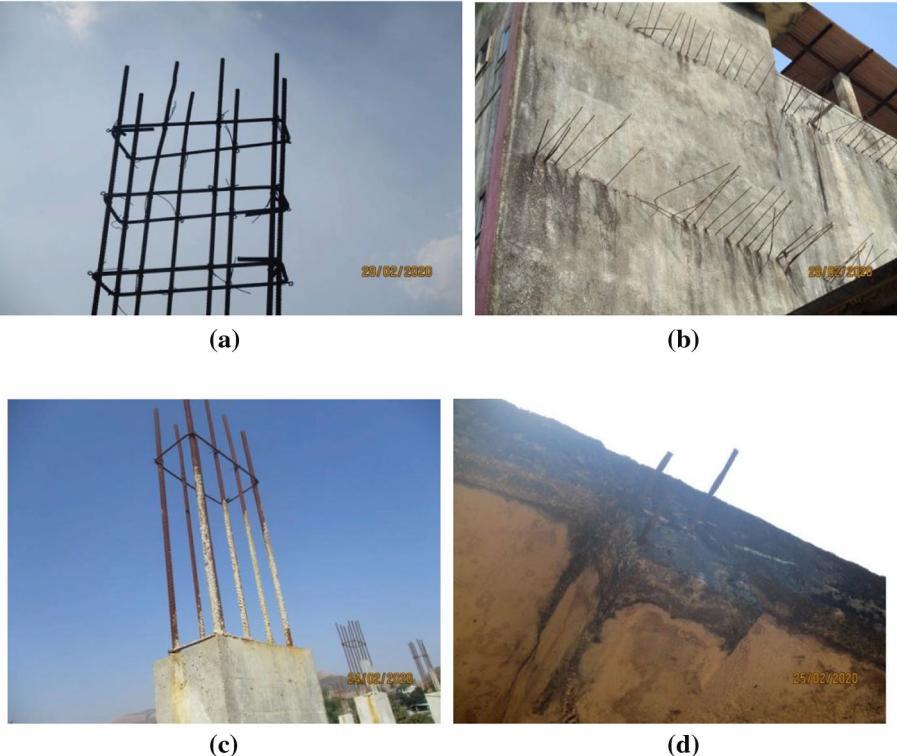
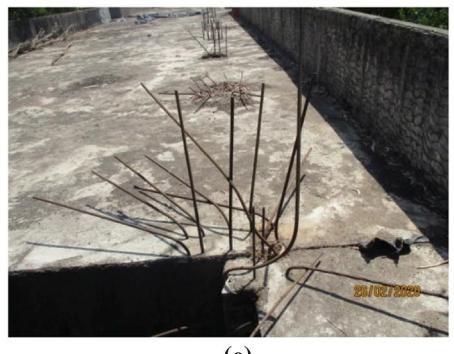
Reinforcement is the most important building material. In field study, we have observed that reinforcement bars are kept open at the terrace as well as roof level in most of the buildings, so the bars get corroded due to contact with the environment. Stirrups bend provision in column and beam is 90° based on the discussion with local engineers and contractors. As per the ductile detailing code, stirrups should be bent in 135°. Relevant pictures of the reinforcements are shown in Fig. 13.

Fig. 13 a Reinforcements are exposed to environment at terrace and stirrups bent at 90°, **b** reinforcements are exposed to environment at roof level, c corroded reinforcement bars. d reinforcements are exposed from beam, e condition of reinforcement bars at terrace

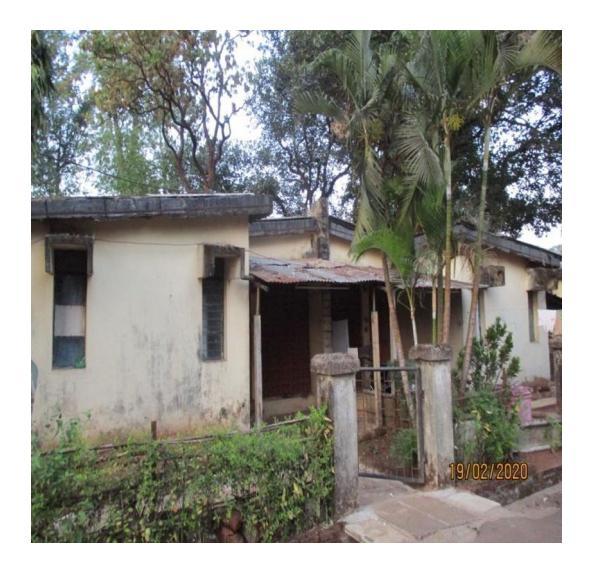
The building (No. 24) presented in the paper is a residential ordinary moment-resisting RC framed building (Fig. 14), located in Zone IV (Koyna-Warna Region) as per IS 1893 Part-1:2016 code. The building was constructed in 1990. Figure 15 shows the floor plan of the building. The building is a single-storied pitched roof building. The height of the roof is 4.25 m from the ground level. The plan dimensions of the building are 11.9 m×4.04 m. The construction drawing specifies that M15 grade of concrete and Fe 415 grade of steel were used for the construction. The floor slabs in the building were assumed to act as rigid diaphragms. The seismic weight and design base shear of the existing building are 1753.16 kN and 15.31 kN, respectively. The response reduction factor and importance factor are 3 and 1, respectively, based on the frame system and its function. The spectral acceleration coefficient is 2.5. The plinth beam is considered Fig. 11 a Pop out of plaster, **b** horizontal crack propagate below the slab, c Shear crack at the corner of window, d Shrinkage cracks on wall, e Diagonal shear crack on column, f Crack on the junction of column and wall

Fig. 14 Photograph of the single-storey RC building understudy

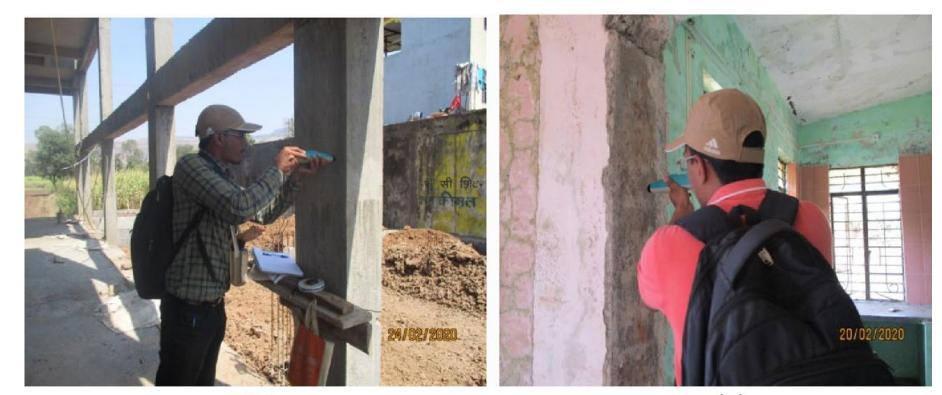
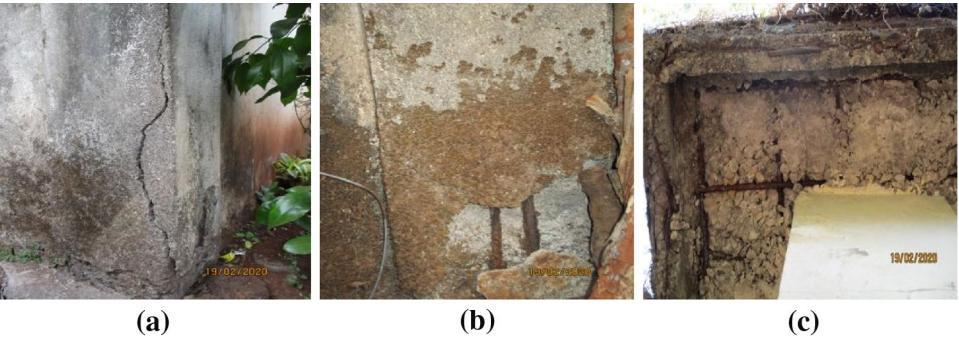
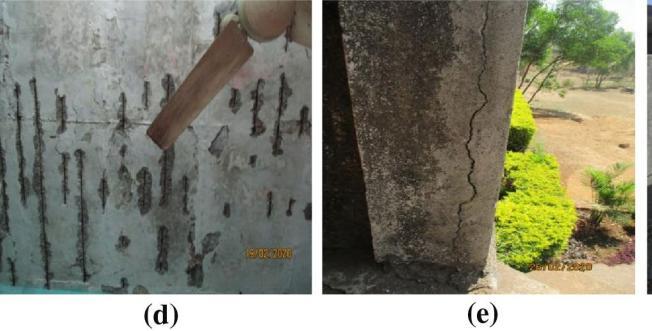
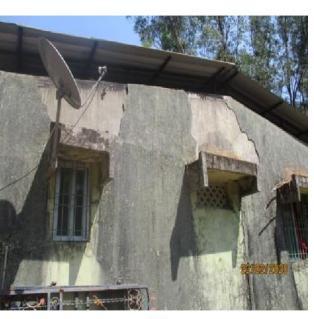
Figure 25 shows the different damage conditions of surveyed sample buildings. The slab leakage problem is observed

almost in all buildings due to heavy rainfall. Structural cracks on the column, corroded reinforcement and spalling of cover concrete observed in columns, reinforcements are exposed outside from slab, scaling of plaster, etc. There might be possible carbonation of concrete in the slab, column of old buildings.

Fig. 25 Damage condition of sample buildings
