Seismic risk assessment of reinforced concrete buildings in Koyna Warna region through EDRI method

Report No: IIIT/TR/2021/-1

Seismic risk assessment of reinforced concrete buildings in Koyna-Warna region through EDRI method

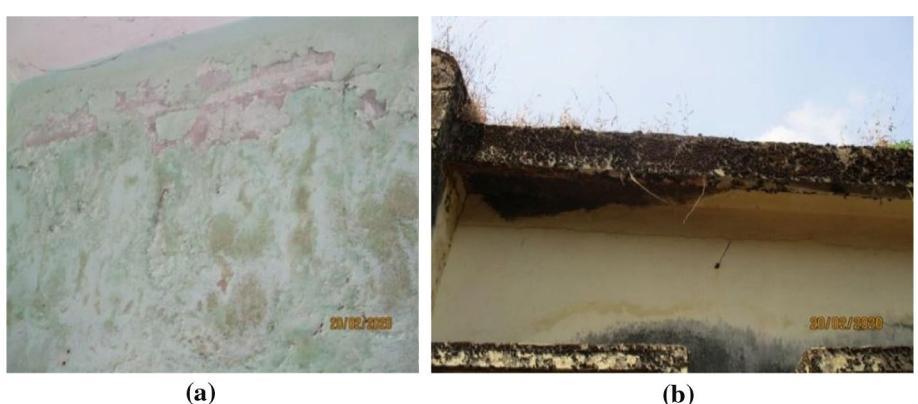
Fig. 14 Photograph of the single-storey RC building understudy

The building (No. 24) presented in the paper is a residential ordinary moment-resisting RC framed building (Fig. 14), located in Zone IV (Koyna-Warna Region) as per IS 1893 Part-1:2016 code. The building was constructed in 1990. Figure 15 shows the floor plan of the building. The building is a single-storied pitched roof building. The height of the roof is 4.25 m from the ground level. The plan dimensions of the building are 11.9 m×4.04 m. The construction drawing specifies that M15 grade of concrete and Fe 415 grade of steel were used for the construction. The floor slabs in the building were assumed to act as rigid diaphragms. The seismic weight and design base shear of the existing building are 1753.16 kN and 15.31 kN, respectively. The response reduction factor and importance factor are 3 and 1, respectively, based on the frame system and its function. The spectral acceleration coefficient is 2.5. The plinth beam is considered Fig. 11 a Pop out of plaster, **b** horizontal crack propagate below the slab, c Shear crack at the corner of window, d Shrinkage cracks on wall, e Diagonal shear crack on column, f Crack on the junction of column and wall

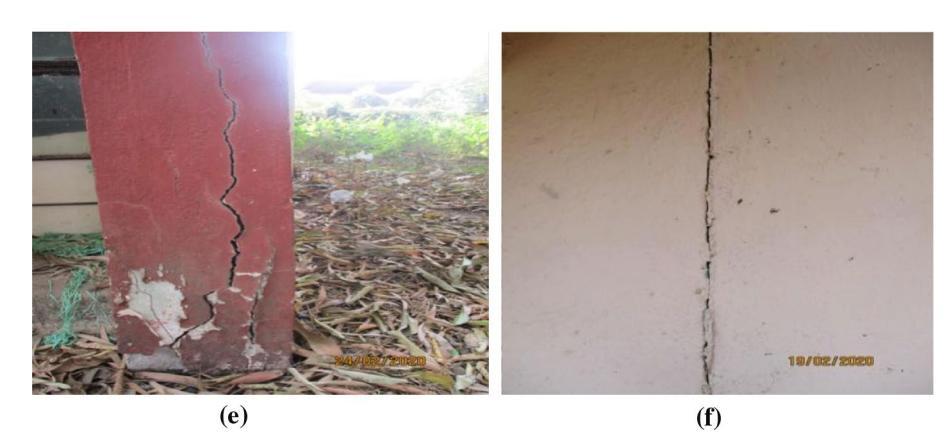
Fig. 16 The model of the single-storey RC building

in the modelling located at ground level (1.5 m above from footing). The stiffness for columns and beams was taken as 0.7EI and 0.5EI, respectively, for accounting the cracks in members as per IS 15988:2013 code. The plan and model of the building is shown in Figs. 15 and 16, respectively. Tables 3 and 4 show the column and beam dimensions, respectively.

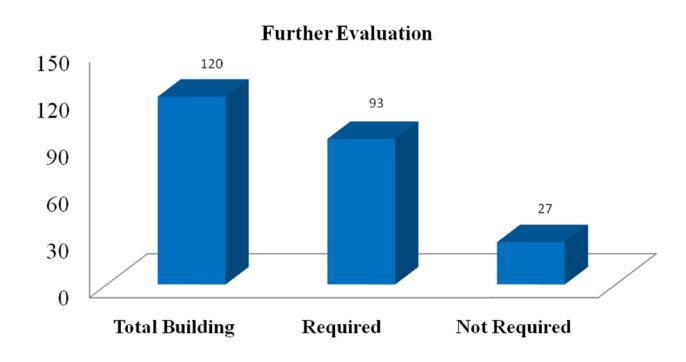
Fig. 20 Further evaluation of RC buildings in Koyna-Warna region

As per Fig. 20, there is a need to evaluate 93 buildings for their further use because of their present moderate, severe and collapse damage conditions that are dangerous to the health of buildings. And there is no need to evaluate 27 buildings which are in no and slight damage condition.

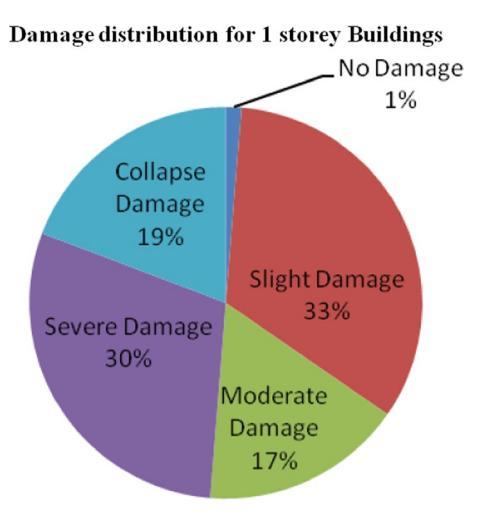
Fig. 21 Damage distributions of single-storey surveyed buildings

Based on Fig. 21, there are 78 single-storey buildings surveyed in the Koyna-Warna region. Out of these, 1% and 33% of buildings are in no and slight damage stages, respectively. The percentage of buildings in moderate and severe damage stages is 17% and 30%, respectively. Out of all buildings, 19% of buildings are in the collapse stage, 51% of buildings are in no, slight, and moderate damage conditions, and 49% of buildings are in severe and collapse damage conditions.

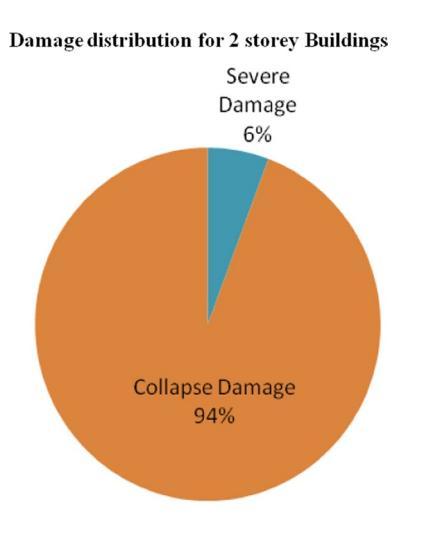
Fig. 22 Damage distributions of two-storey surveyed buildings

Based on Fig. 22, there are 35 two-storey buildings surveyed in the Koyna-Warna region. Out of these, 6% and

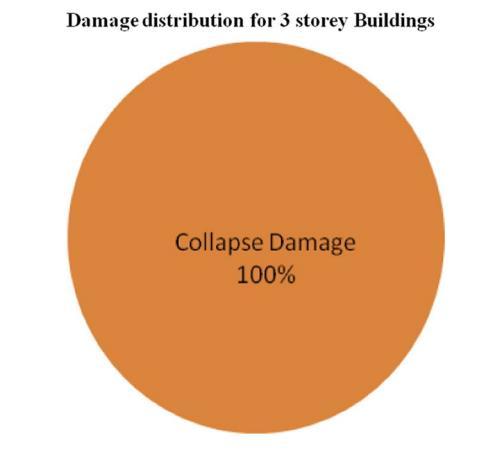
Fig. 23 Damage distribution of three-storey surveyed buildings

Based on Fig. 23, there are 7 three-storey buildings surveyed in the Koyna-Warna region. Out of these, all buildings are in the collapse damage stage. There is no building in no, slight, moderate and severe damage conditions. As the storey of the building increases, the exposure term will increase, so ultimately the risk index of the building also increases. Hence, all three-storey buildings may be in the collapse damage stage.
